ROAD SAFETY AUDIT

Massachusetts Avenue at
Melnea Cass Boulevard

City of Boston

July 19, 2016

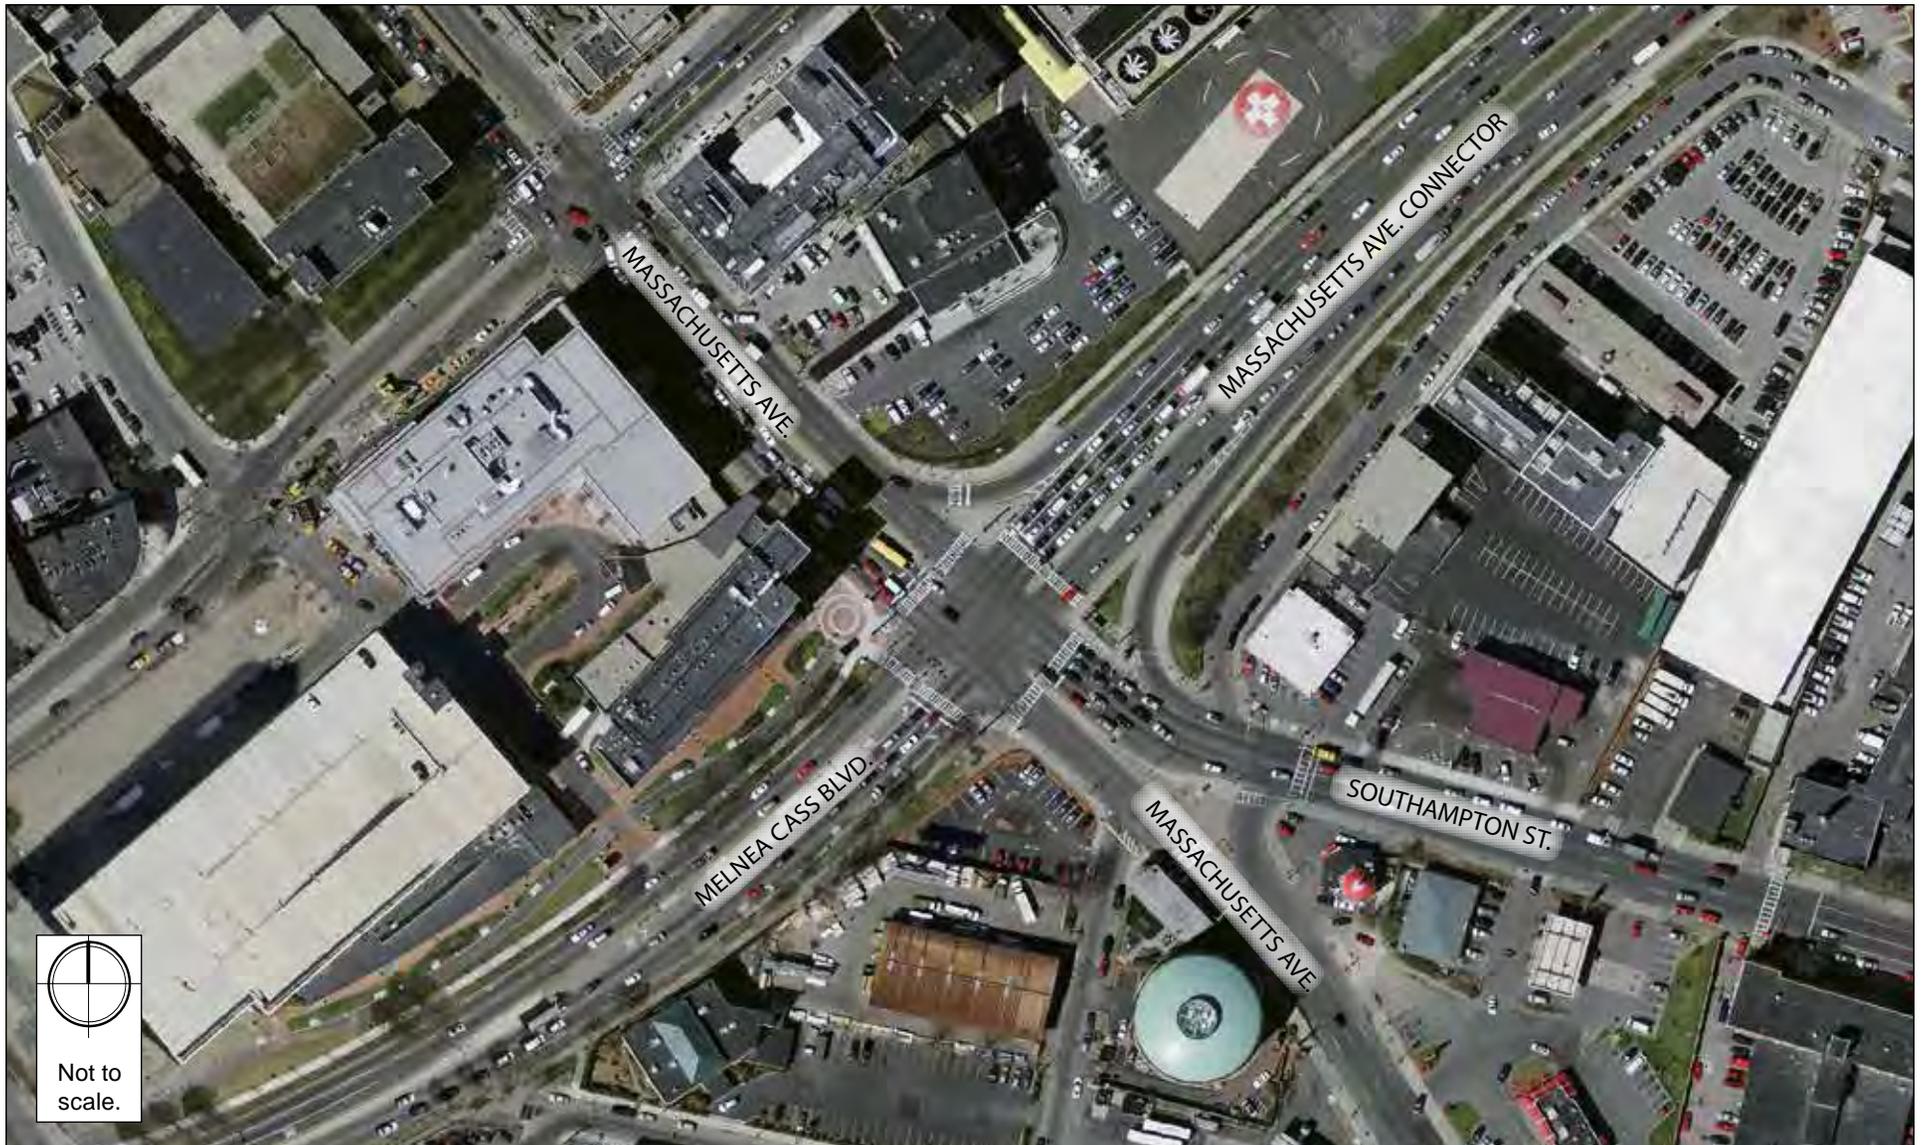
Figure 2. Massachusetts Avenue at Melnea Cass Boulevard

The RSA focused on the intersection of Melnea Cass Boulevard at Massachusetts Avenue in Boston, as shown in the aerial image in **Figure 2**.

Massachusetts Avenue at Melnea Cass Boulevard is a signalized intersection with four approaches. The Melnea Cass Boulevard eastbound approach consists of two through lanes and an exclusive right-turn lane with three receiving lanes provided along the Massachusetts Avenue Connector eastbound. Signage on the eastbound approach restricts vehicles from turning left onto Massachusetts Avenue. The Massachusetts Avenue Connector westbound approach consists of two exclusive left-turn only lanes, two through lanes, and a signal controlled channelized right-turn lane. It was observed that vehicles often use the Massachusetts Avenue Connector westbound channelized right-turn lane as two lanes. A raised median that varies from 5 to 8 feet wide separated the directions of travel along the Melnea Cass Boulevard and the Massachusetts Avenue Connector approaches. The Massachusetts Avenue Connector westbound through lanes are provided two receiving lanes along Melnea Cass Boulevard westbound. The Southampton Street northbound approach consists of two exclusive left-turn only lanes, two through lanes, and a channelized right-turn lane with two receiving lanes provided northbound along Massachusetts Avenue. The Massachusetts Avenue southbound approach consists of two exclusive left-turn only lanes, a through lane, and a shared through/right-turn lane. The two through lanes are provided with three receiving lanes along Massachusetts Avenue south of the intersection. A 6-foot raised median separates the north-south directions of travel along the northbound and southbound intersection approaches.

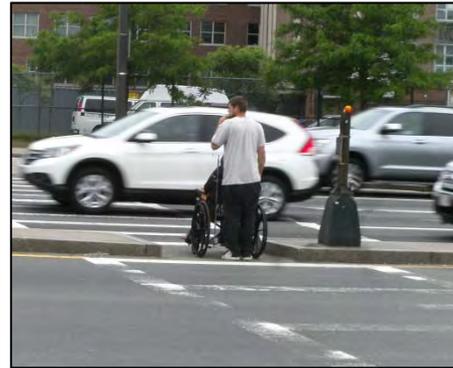
13 of the 112 reported crashes involved pedestrians. Many of these collisions are the result of pedestrians walking outside of the crosswalks along the intersection approaches. Sidewalks are provided along both sides of all intersection approaches. Crosswalks with pedestrian signals and pushbuttons are also provided across all intersection approaches. Wheelchair ramps are provided at all the crosswalks but lack detectable warning panels and may not have compliant slopes or level landings. The proximity of local shelters and the Boston Medical Center reinforces the strong need for adequate and accessible sidewalks, wheelchair ramps, and pushbuttons.

Person in wheelchair crossing the Massachusetts Avenue Connector in the crosswalk.

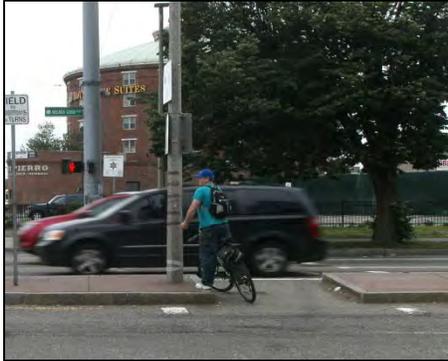
Cyclist crossing Melnea Cass Boulevard in the crosswalk.

Four of the 112 reported crashes involved a cyclist. Bicycle accommodations at the intersection of Massachusetts Avenue/Melnea Cass Boulevard are limited and most approaches do not have any bicycle accommodations. The South Bay Harbor Trail runs along Melnea Cass Boulevard to the intersection with Massachusetts Avenue and there are plans to expand the trail further east in the future. In addition a northbound bike lane is located on Massachusetts Avenue north of the intersection. Cyclists are only provided sharrows when approaching the intersection on Massachusetts Avenue southbound. Despite the lack of formal accommodations, bicycle volumes within the intersection are relatively heavy. The lack of formal separation from vehicles along the northbound and southbound approaches at

a complex and high volume intersection creates an uncomfortable situation for cyclists. During the audit, multiple cyclists were observed to cross the intersection using the crosswalks and pedestrian signals in order to safely navigate the intersection.

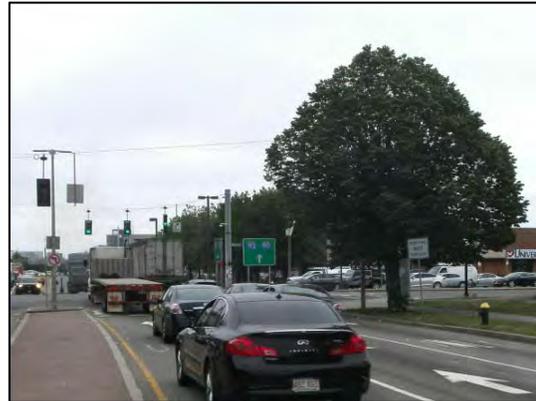
The Melnea Cass Boulevard eastbound approach consists of two through lanes and a right-turn only lane. Left-turns are prohibited at this approach by three diagrammatic no left-turn signs (R3-2 Movement Prohibition signs) located along the approach on the center median. Three of the 112 crashes reported involved vehicles taking an illegal left-turn from Melnea Cass Boulevard and hitting a vehicle traveling westbound from the Massachusetts Avenue Connector. It was noted by an audit member that this turn restriction was implemented within the last 5 years and that while some vehicles still execute the left-turn, vehicle compliance overall has been increasing. An audit team member noted that GPS technologies may not be up to date with the most recent turning restrictions at the intersection and could potentially be directing vehicles to take the left-turn from Melnea Cass Boulevard.

Lane use guidance along the Melnea Cass Boulevard approach.

10 of the 112 crashes were sideswipe crashes that occurred along the intersection approaches. Audit members noted that vehicles often end up in the turning lanes inadvertently when approaching the intersection causing drivers to make last minute lane changes. Along the Melnea Cass Boulevard eastbound approach, two “Right Lane Must Turn Right (R3-7) signs, are provided and a diagrammatic right-turn only (R3-5R) sign which shows a right-turn arrow above the word “ONLY” is provided on the span wire across the intersection; however, these signs are not clearly visible until you are already in the right-turn lane. Two of the sideswipe collisions along this approach involved vehicles moving from the right-turn lane to the adjacent through lane which could indicate that drivers are not provided warning far in enough in advance of the turn lane.

2. Consider providing lane drop markings in advance of the right-turn lane on Melnea Cass Boulevard to alert drivers of the transition to a turning only lane. The proposed pavement markings would transition from the broken white lane lines to wide dotted white lane lines and then a wide solid white lane line.

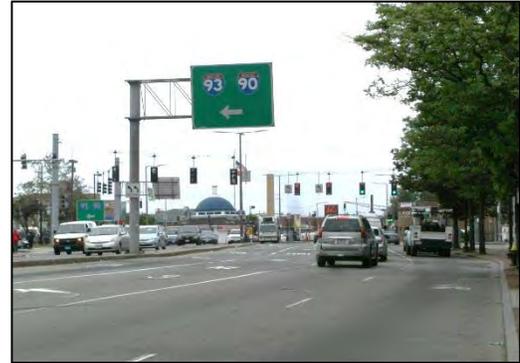
The Massachusetts Avenue southbound approach consists of two left-turn only lanes, a through lane, and a shared through/right-turn lane. While traveling southbound on Massachusetts Avenue one of the through lanes becomes a left-turn only lane when approaching the intersection with Melnea Cass Boulevard and the Massachusetts Avenue Connector. An overhead guide sign directs vehicles to turn left for I-90 and I-93 and two signs are provided on the center median which show that the two left lanes are left-turn only lanes. However, no pavement markings or guidance is provided for the remaining two lanes. Two sideswipe crashes were reported along this approach which involved vehicles changing lanes through traffic.

Lack of lane use and guide signs on the Massachusetts Avenue southbound through lanes.

Audit members who routinely drive the area also noted that this approach is confusing for drivers and vehicles have a difficult time deciding which lane to be in and often require attempting last-minute lane changes. During the audit, a vehicle was observed to be in the inside left-lane trying to signal to other vehicles that it actually needed to turn right. An audit member noted that it is typical to see drivers intentionally choose the outside left-turn lane because it had a shorter queue than the through lanes causing them to get stuck in a turn-only lane. The heavy congestion along the intersection approach also makes it more difficult for drivers to change lanes.

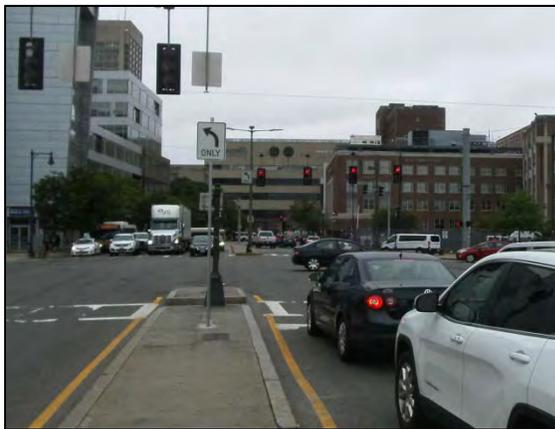
Lane use signs along the Southamptton Street approach.

Two rear-end crashes were reported along the Southamptton Street approach. There is a diagrammatic left-turn only (R3-5) sign with a single left-turn arrow on the center median of the approach; however, there are two dedicated left-turn lanes for this approach. In addition, there is another diagrammatic left-turn only (R3-5) sign mounted overhead on the span wire for the inside left-turn lane only. There is no sign adjacent to the signal head for the middle left-turn lane. Lane assignment confusion could lead to drivers to queue in the incorrect lane or execute late lane changes which could contribute to the number of rear-end crashes at this approach.

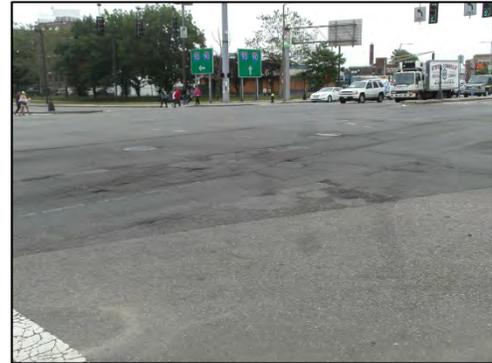
During the audit, team members observed that pavement markings were worn and in poor condition. The pavement within the intersection was observed to be in poor condition with potholes and cracking experienced. An audit team member also observed that there was rutting likely due to heavy truck traffic along the Massachusetts Avenue Connector westbound approach.

Worn pavement and pavement markings within the intersection.

5. Consider resurfacing the intersection to improve pavement condition. The potential for structural issues should also be explored as they could be contributing to the poor pavement condition.

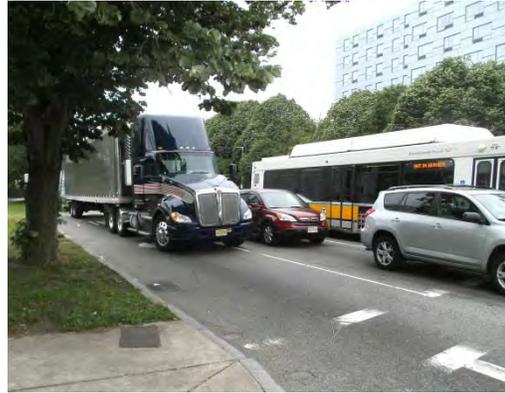
The study area intersection carries heavy percentages of truck traffic due to the proximity to the highway to the east of the intersection and nearby layover and industrial sites to the south of the intersection. During the audit, turning trucks were observed to make wide turns which require tracking into multiple lanes when executing right-turns. In addition, multiple trucks were observed to drive over the corner curb when turning right from Melnea Cass Boulevard onto Massachusetts Avenue and when using the channelized right-turn from Southampton Street to the Massachusetts Avenue Connector. Heavy vehicle encroachment into adjacent lanes or heavy vehicles mounting the curb during a turn could lead to potential conflicts with adjacent vehicles or pedestrians waiting on the sidewalk.

Tractor trailer in right-turn lane on Melnea Cass Boulevard encroaching on through lane.

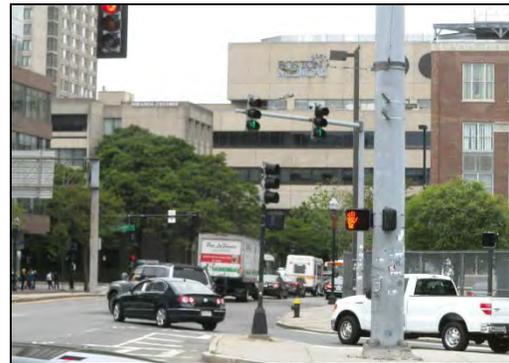
Right-turning vehicles spilling back onto the Massachusetts Avenue Connector.

Two rear-end crashes were reported along the Massachusetts Avenue Connector channelized right-turn lane. It was observed that the right turning movement from the Massachusetts Avenue Connector to Massachusetts Avenue toward Albany Street is a very heavy movement. During the audit, vehicles making this movement were observed to have a green light for the right turn and then a red light when approaching Albany Street. Due to the heavy volume, vehicles were queued in the middle through lane spilling back onto the Massachusetts Avenue Connector. The heavy congestion and queuing experienced along the right-turn lane helps contribute to the amount of rear-end crashes when vehicles do not see the traffic slowing in front of them.

4. Consider reconstructing the two existing channelized right-turns and widening the channelized right-turn from the Massachusetts Avenue Connector to be two lanes since vehicles already stack in two lanes under existing conditions.

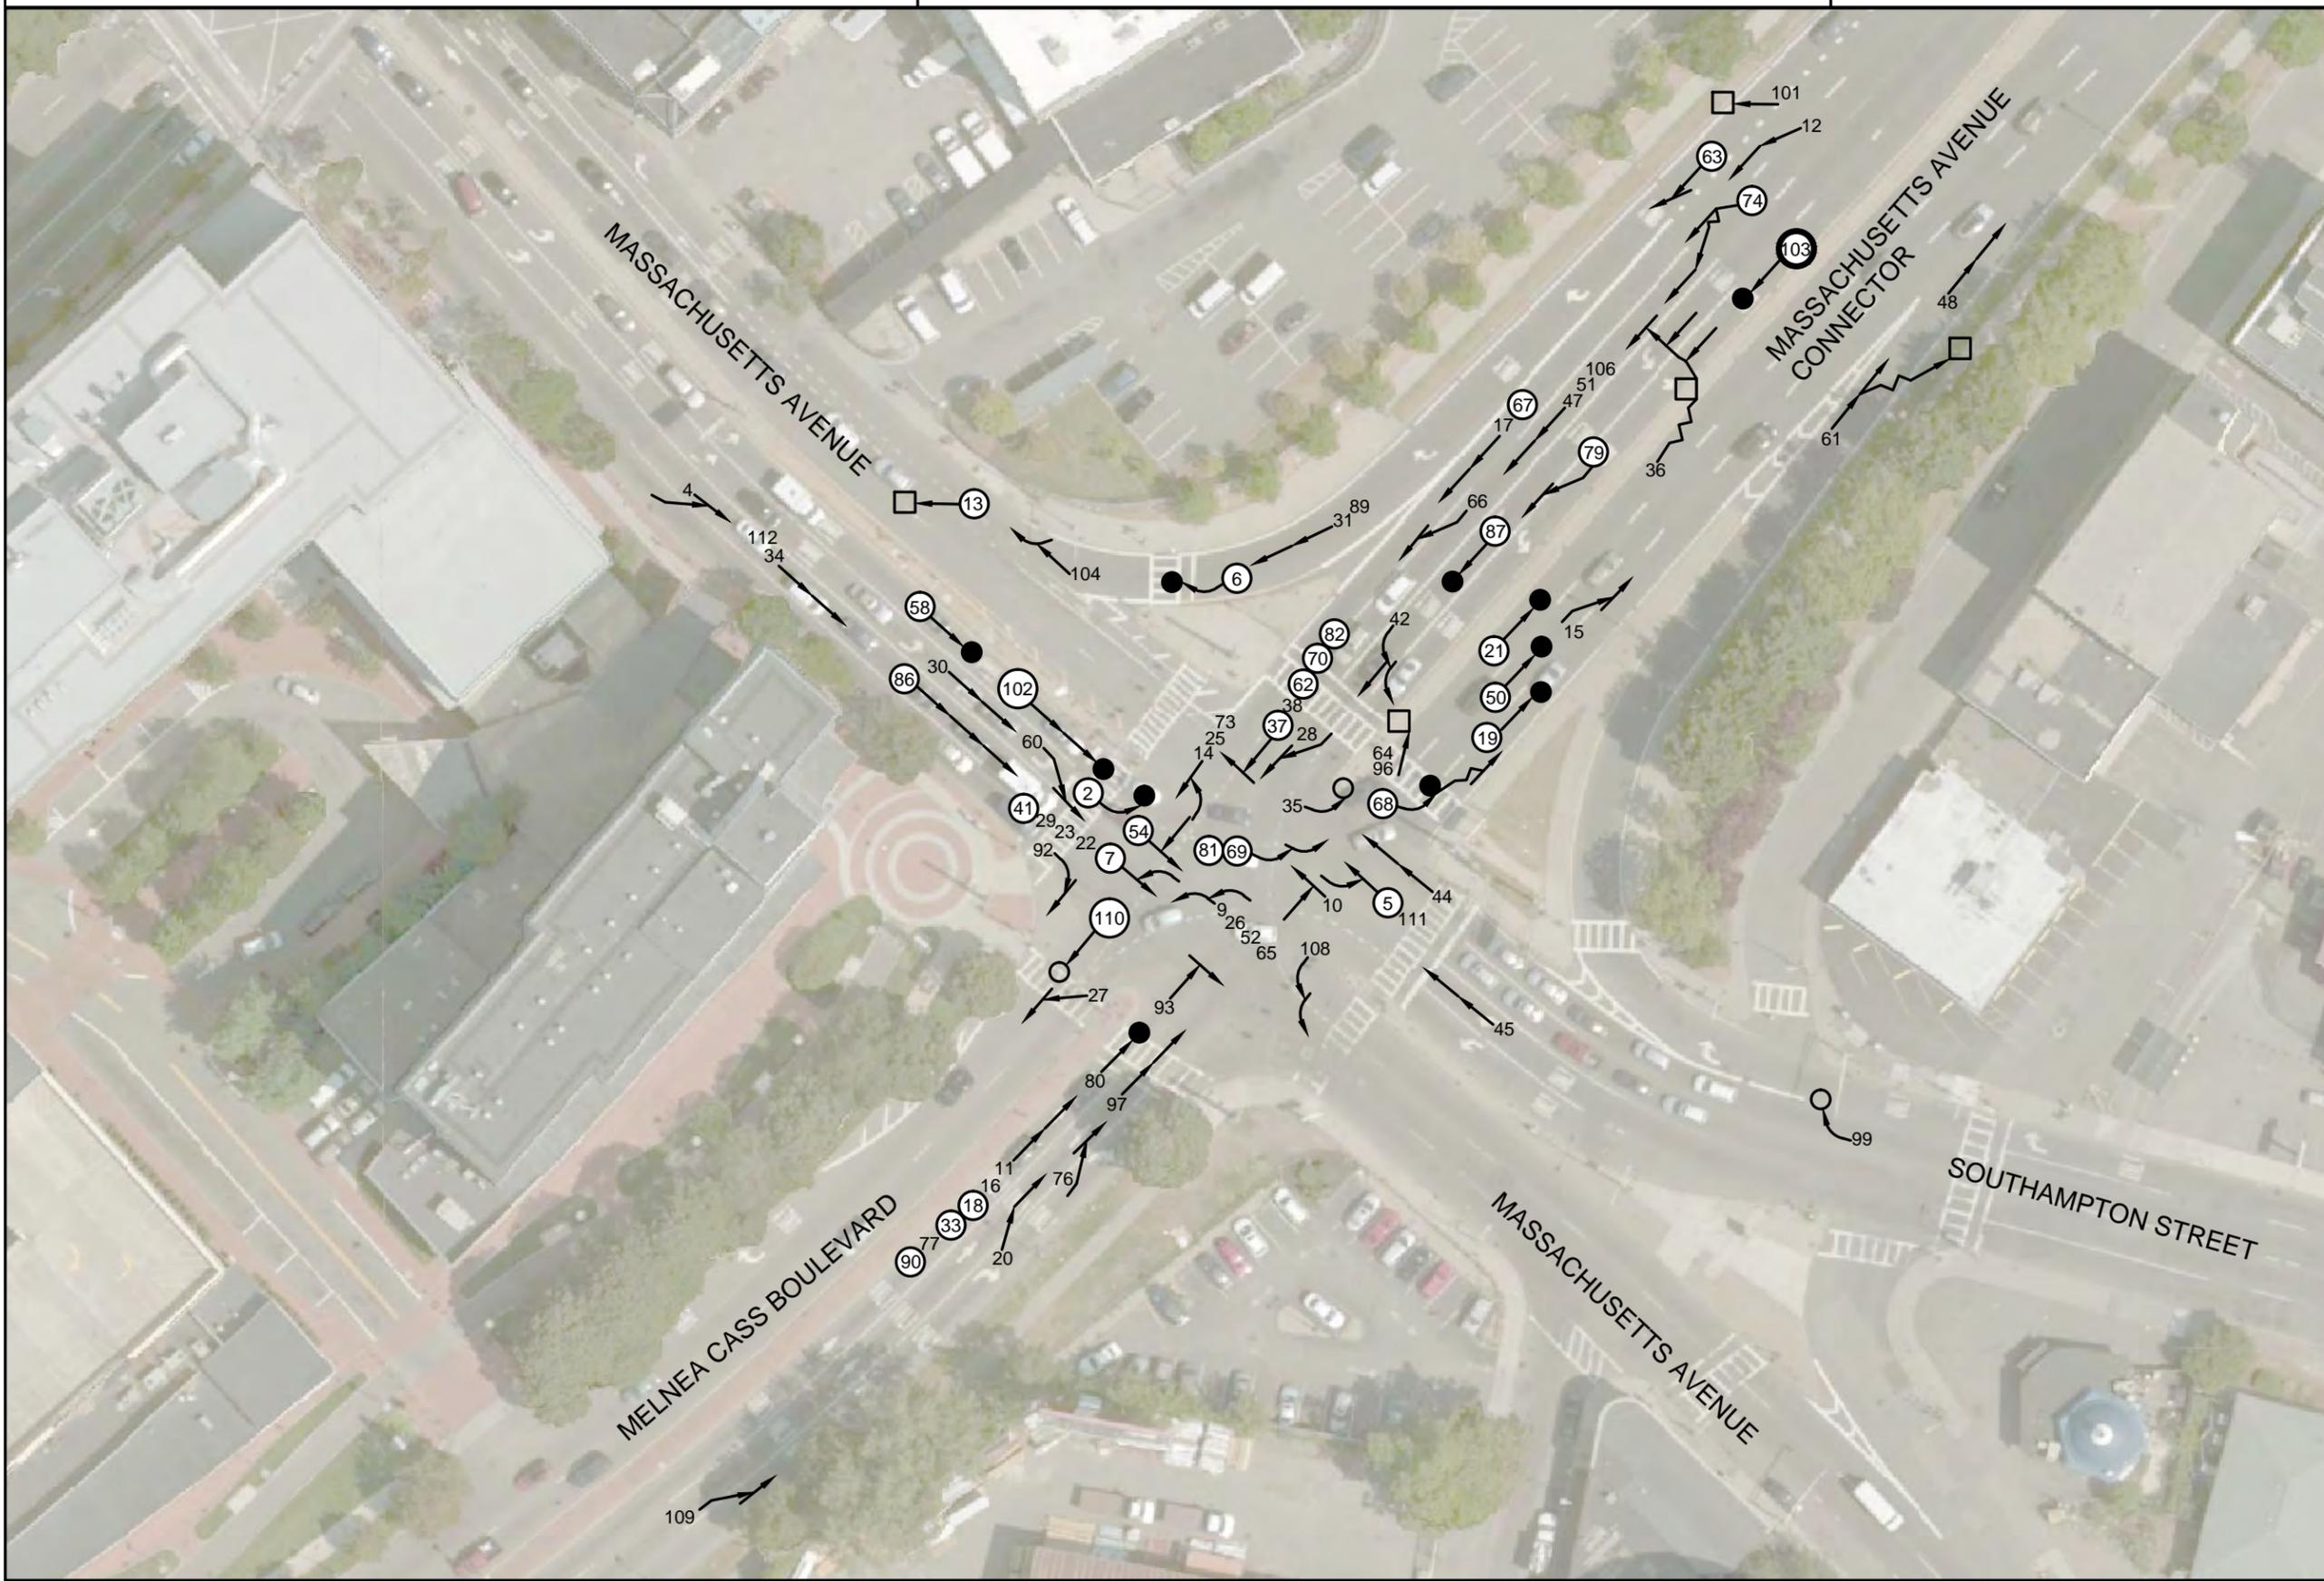
BOSTON, MA
MASSACHUSETTS AVE AT MELNEA CASS BLVD
REGION: BOSTON MPO
COLLISION DIAGRAM

TIME PERIOD ANALYZED: JAN 2012 - DEC 2014
SOURCE OF CRASH DATA: STATE AND BOSTON POLICE
DATE PREPARED: APRIL 18, 2016
PREPARED BY: D. CARRON
